# VEHICLE INSPECTION REPORT

**KU61ECC**

## Volvo FMX 380

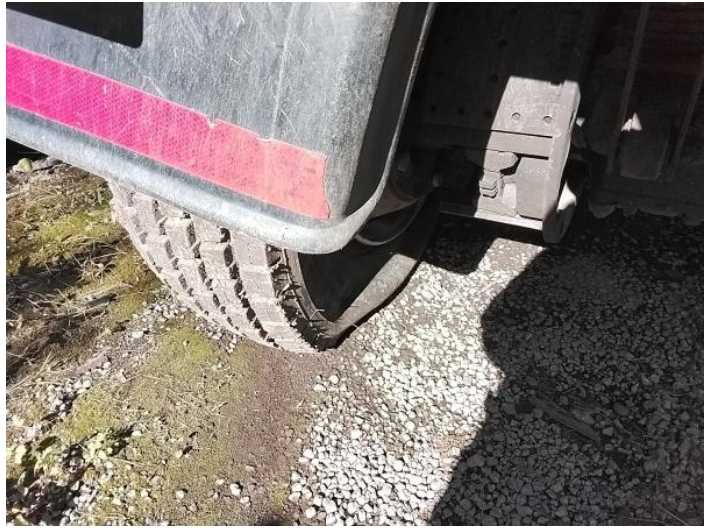
10: Wheel nsr  
Missing  
Replace

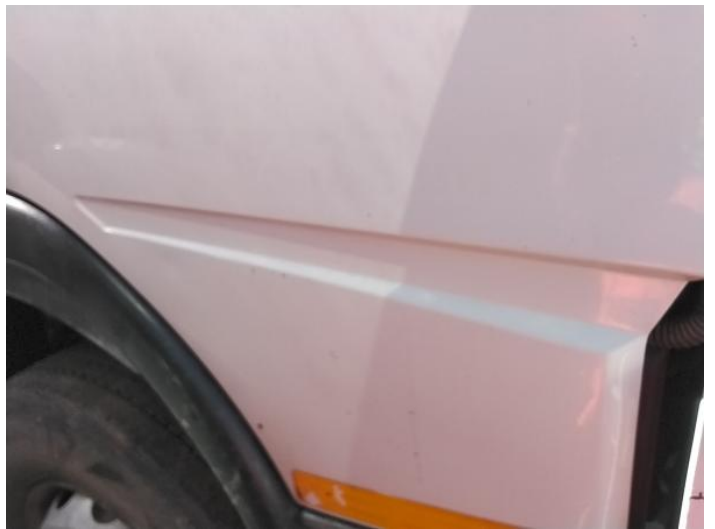
12: Door osf  
Chipped  
Multiple Chips
