VEHICLE INSPECTION REPORT

PJ20UNS

Mercedes-Benz Sprinter 314 CDI

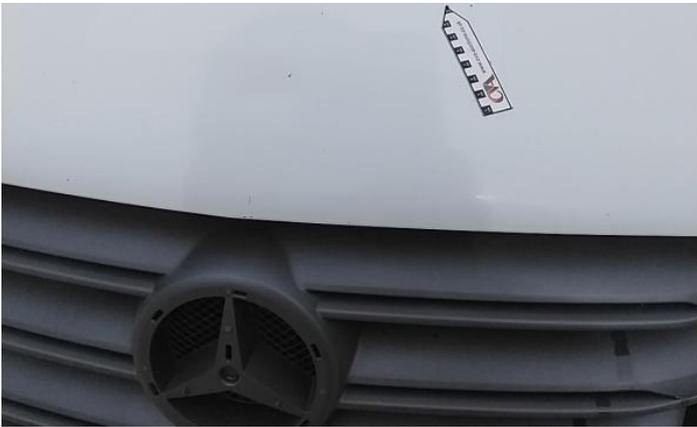
1: Bonnet
Chipped
Multiple Chips

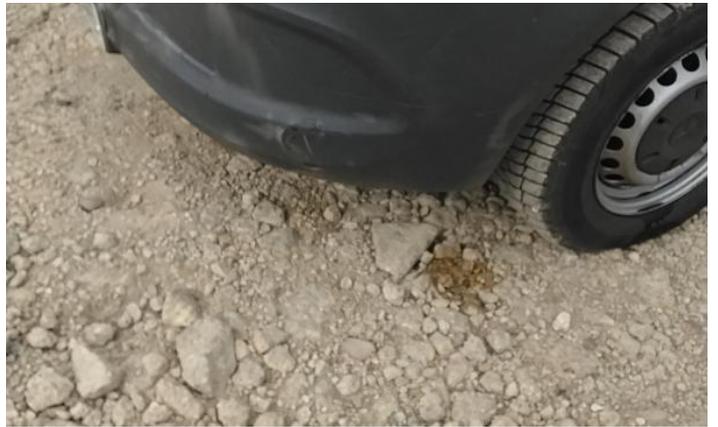
2: Bumper Front
Poor Previous Repair
Paint Flake

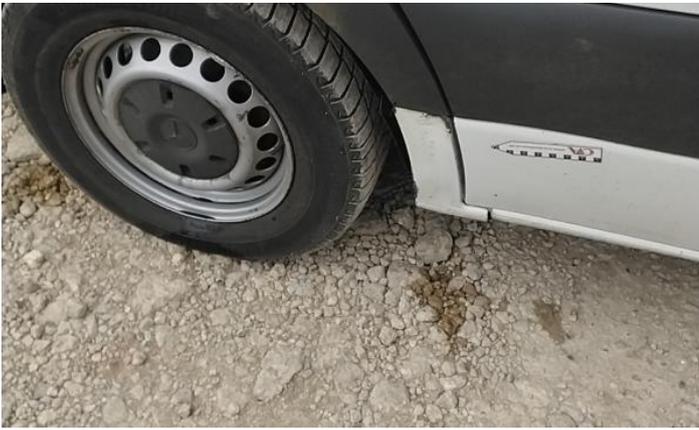
3: Wing nsf
Dented
Over 30mm

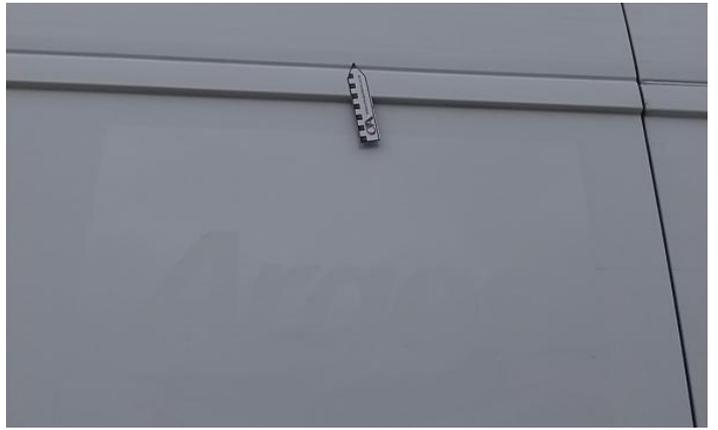
4: Qtr Panel nsr
Scratched
Over 25mm Thru Paint

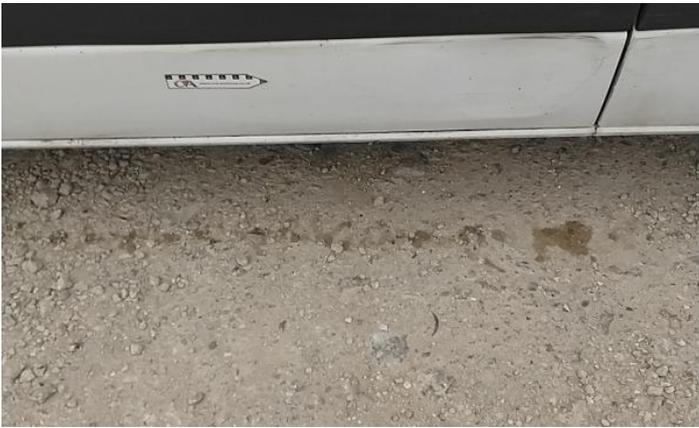
5: Sill ns
Dented
Over 30mm

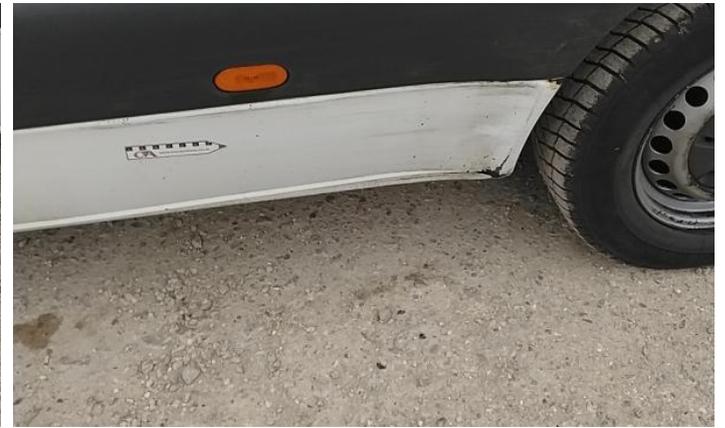
6: Sill ns
Dented
Over 30mm

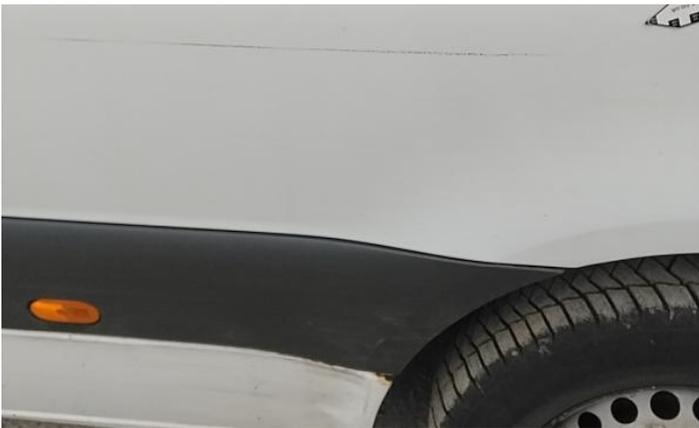
7: Qtr Panel nsr
Scratched
Over 25mm Thru Paint

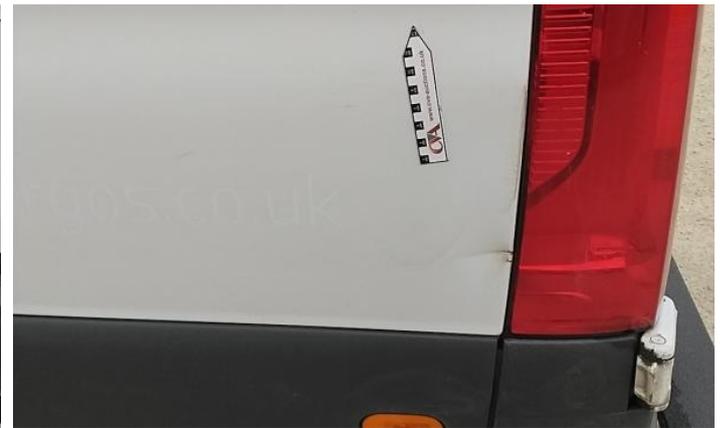
8: Qtr Panel nsr
Scratched
Over 25mm Thru Paint

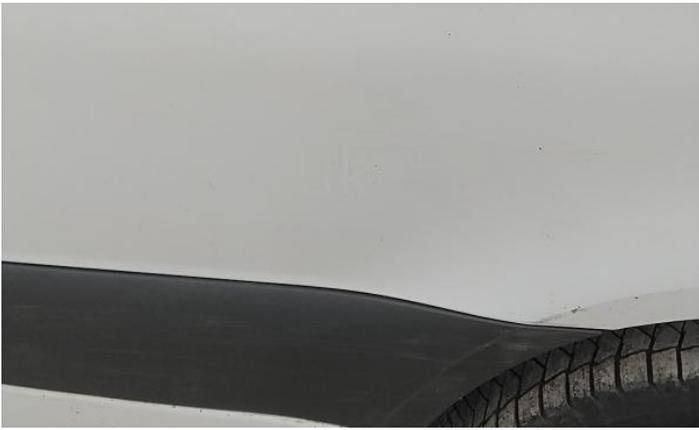
9: Qtr Panel osr
 Scratched
 Over 25mm Thru Paint

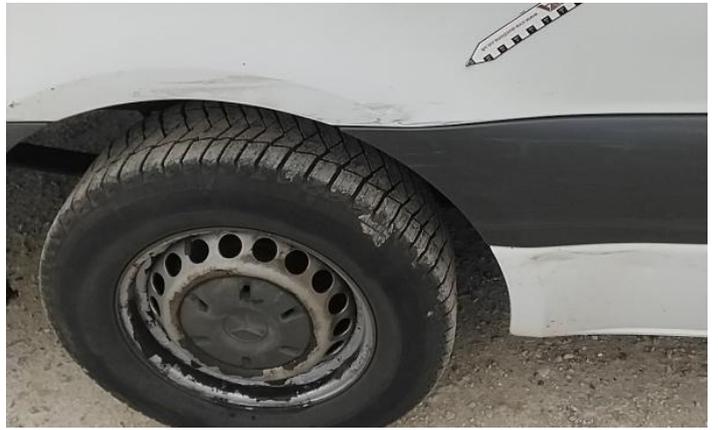
10: Qtr Panel osr
 Scratched
 Over 25mm Thru Paint

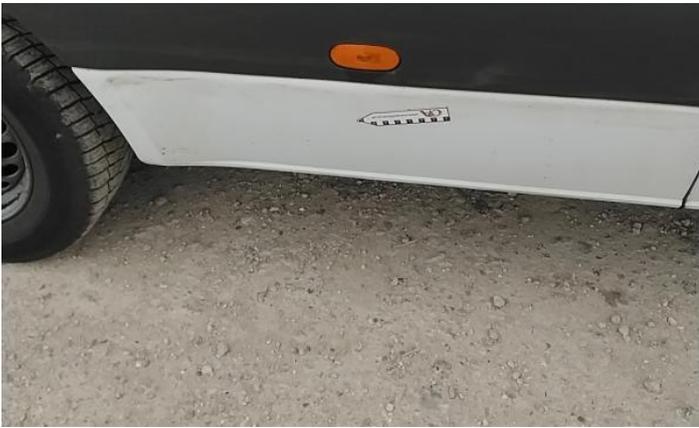
11: Sill os
 Dented
 Over 30mm
