## VEHICLE INSPECTION REPORT

**PF14TZB**

### Daf LF 150

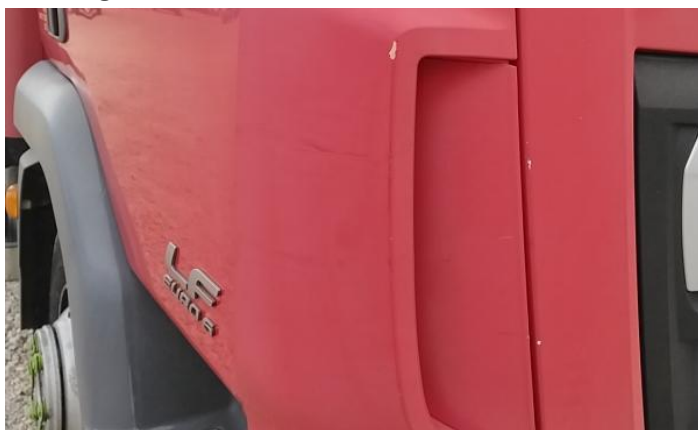
1: Wing osf  
Scratched  
UpTo 25mm Thru Paint

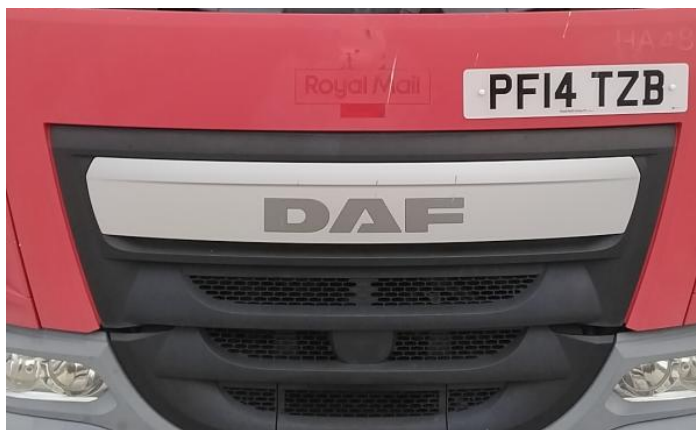
2: Bonnet  
Scratched  
Over 25mm Thru Paint

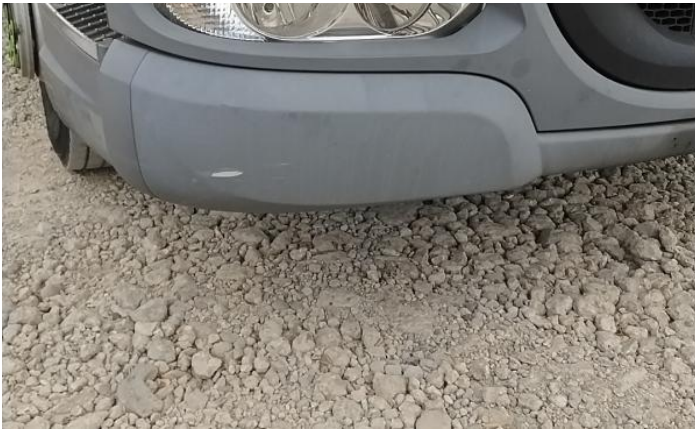
3: Bumper Front  
Scratched  
UpTo 25mm Thru Paint

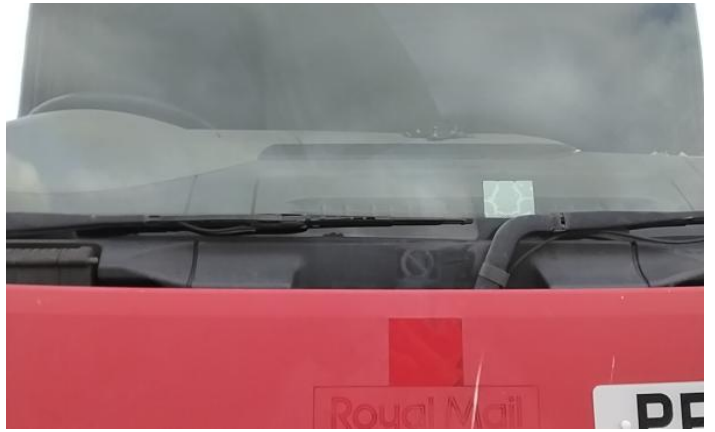
4: Screen Front  
Chipped  
Over 10mm

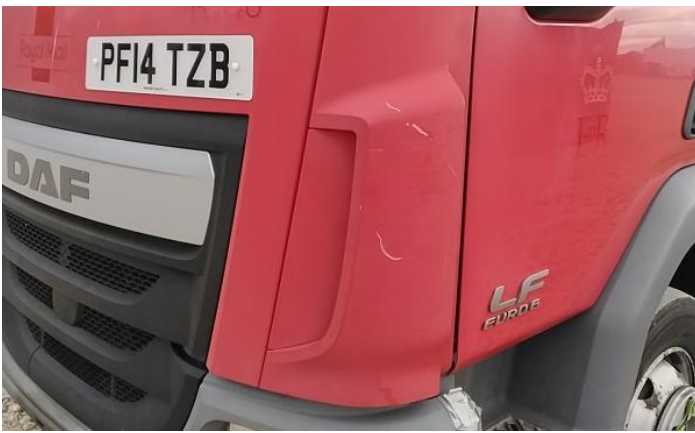
5: Wing nsf  
Scratched  
Over 25mm Thru Paint

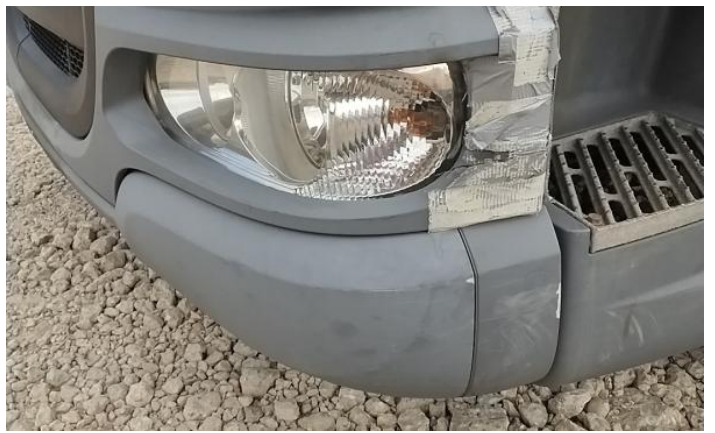
6: Fog Lamp Surround ns  
Broken  
Replace

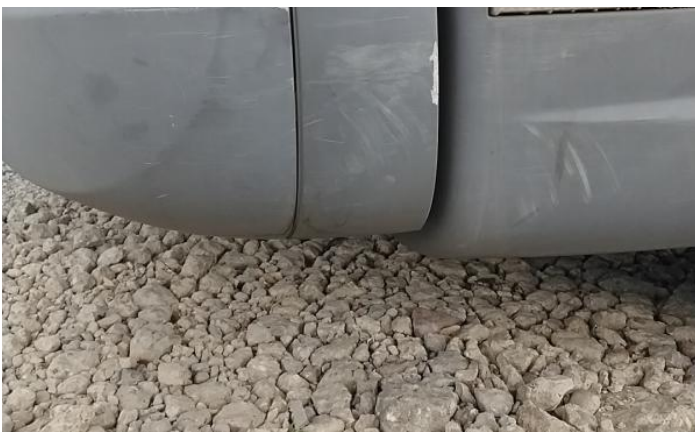
7: Bumper Front  
Scratched  
25 to 100mm Thru Paint

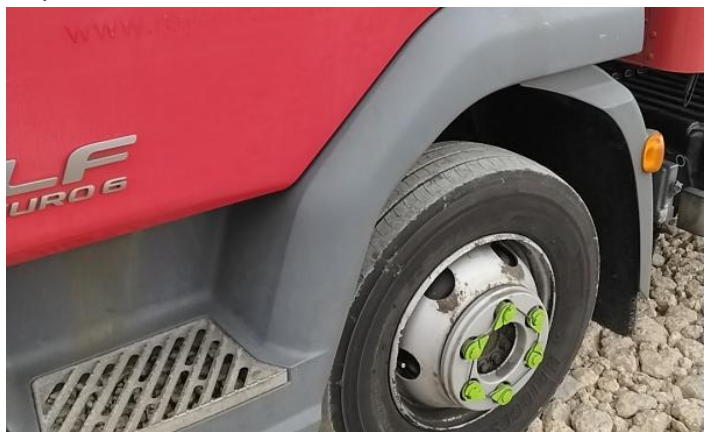
8: Wing Front Arch Extension ns  
Scuffed (Unpainted)  
Over 100mm

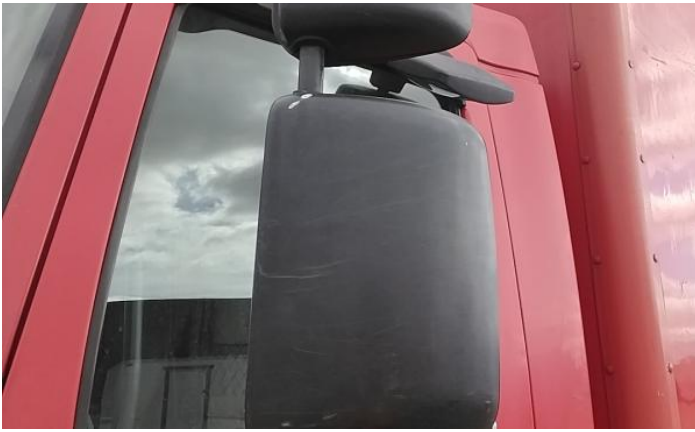
9: Door Mirror Assy nsf  
Scuffed (Unpainted)  
Over 100mm

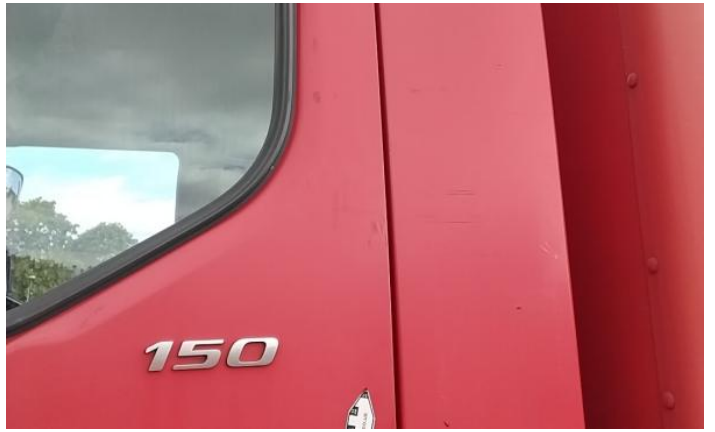
10: Door nsf  
Scratched  
Over 25mm Not Thru Paint

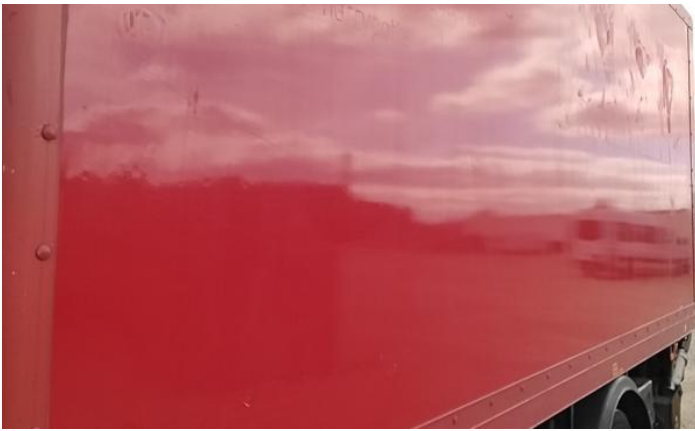
11: Qtr Panel nsr  
Scratched  
Over 25mm Not Thru Paint

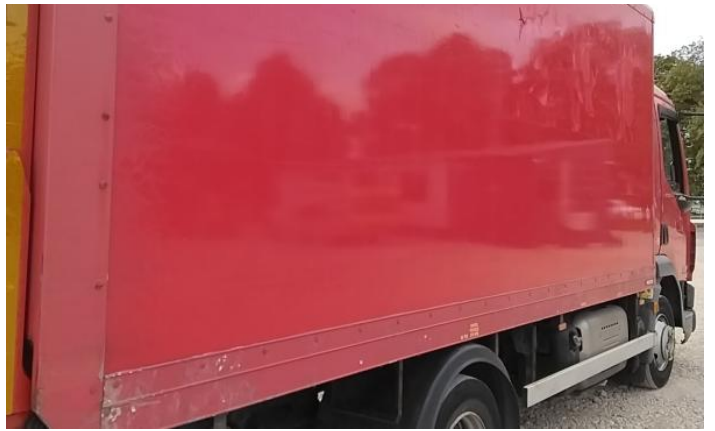
12: Qtr Panel osr  
Scratched  
Over 25mm Not Thru Paint

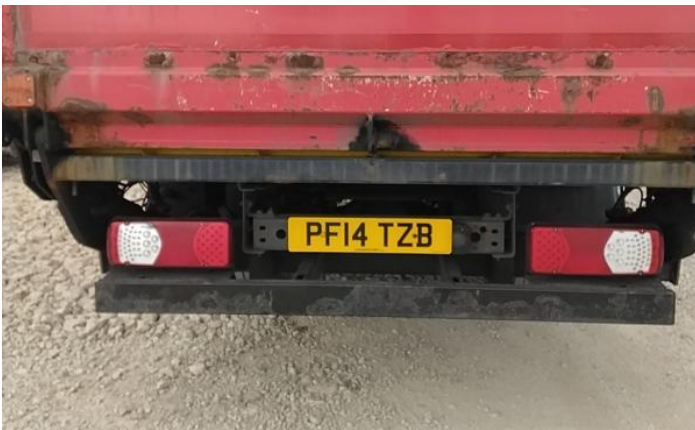
13: Bumper Rear  
Rusted  
Over 5mm

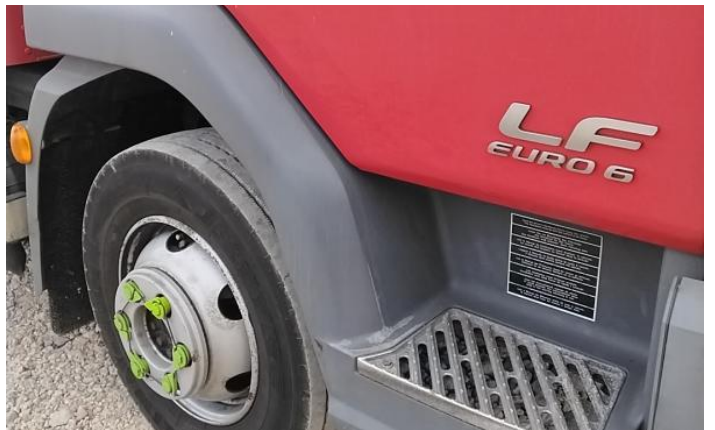
14: Wing Front Arch Extension os  
Scuffed (Unpainted)  
Over 100mm

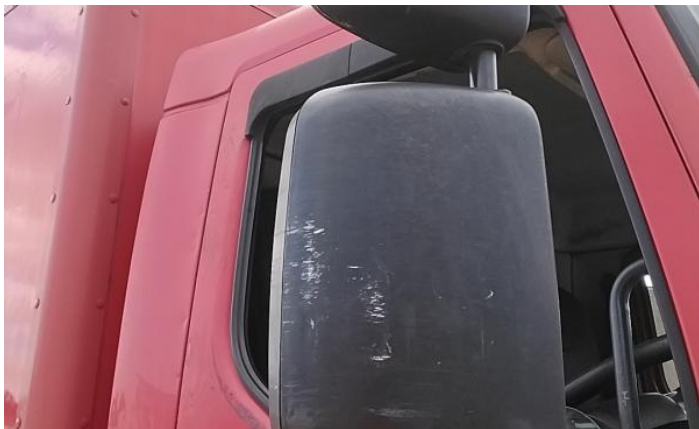
15: Door Mirror Assy osf  
Scuffed (Unpainted)  
Over 100mm

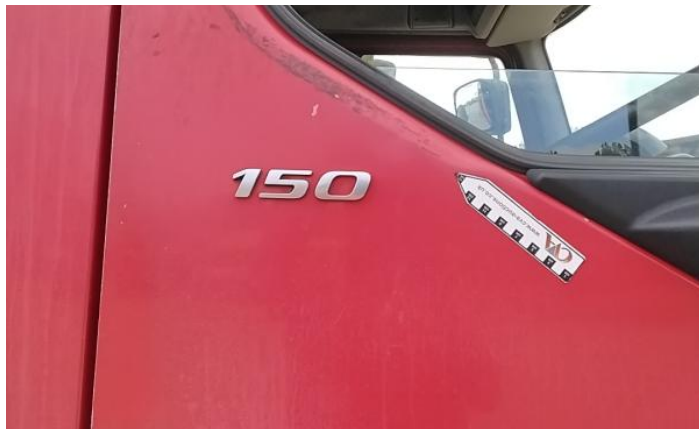
16: Door osf  
Scratched  
Over 25mm Not Thru Paint

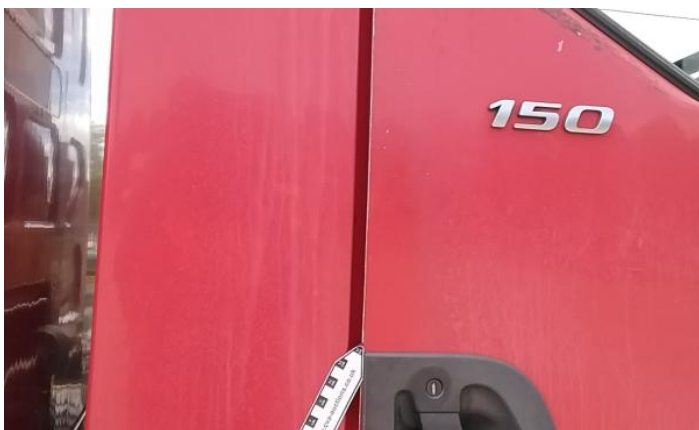
17: Door osf  
Chipped  
Edge Chip

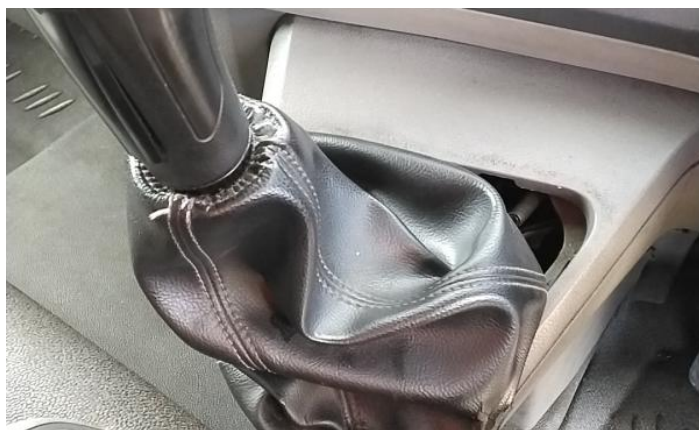
18: Centre Console Front  
Broken  
Replace
